Current Status of Fukushima Dai-ichi NPP and Future Plan

November 7, 2013

Kazuhiko YAMASHITA
Tokyo Electric Power Company

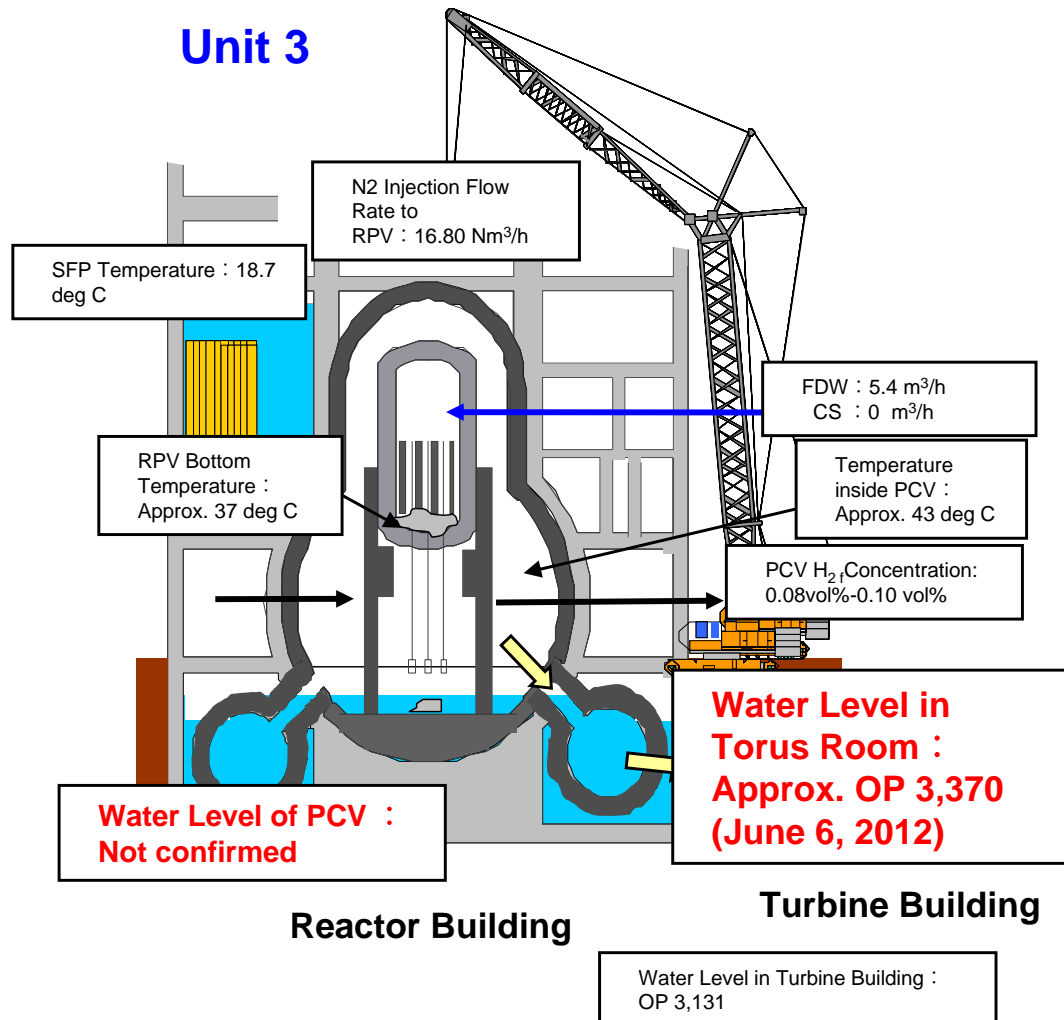
Current Status of Unit 3

- Robot survey in the TIP room in the Reactor Building (2012/3)
 - Water level measurement in Torus Room (2012/6, 7)
- ⇒ Torus Room Water Level : Approx. OP 3,370

Water Level
Torus Room	OP 3370
Staircase area	OP 3150

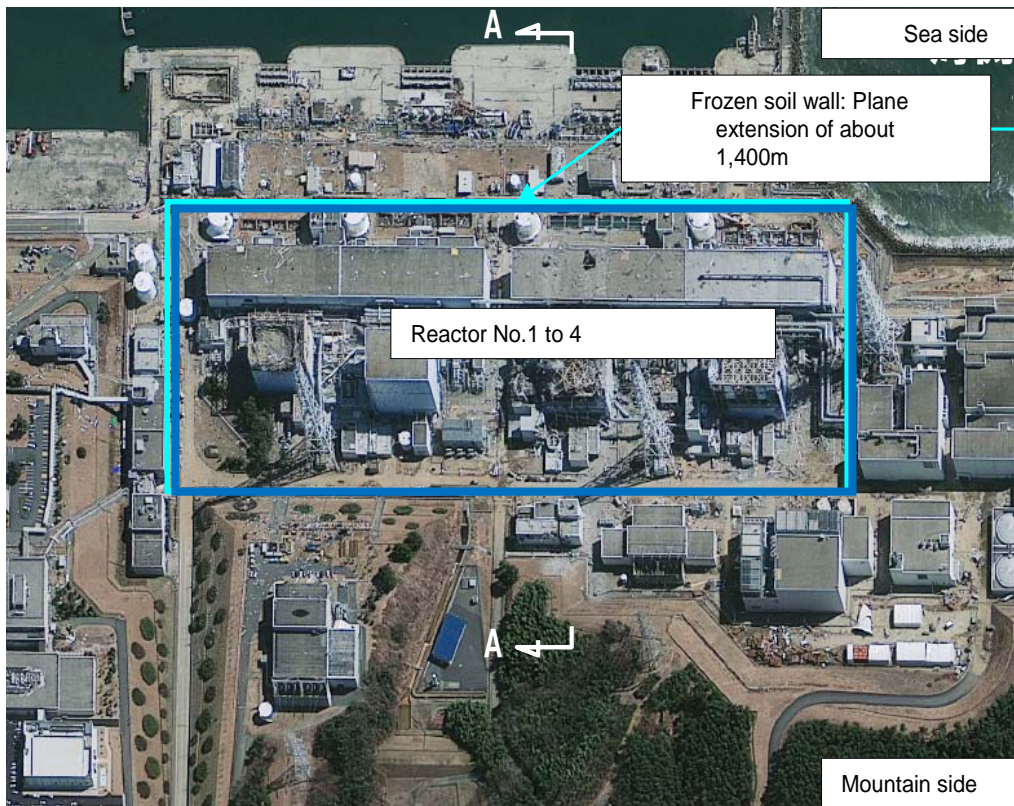
4-3. Fundamental remedies (⑥Land-side Impermeable Wall)

- Surround the turbine/reactor building with frozen soil wall.
Prevent the groundwater from flowing in the area and contaminated water from flowing out from the area.
- Following the feasibility study, targeted completion is in the first half of 2015

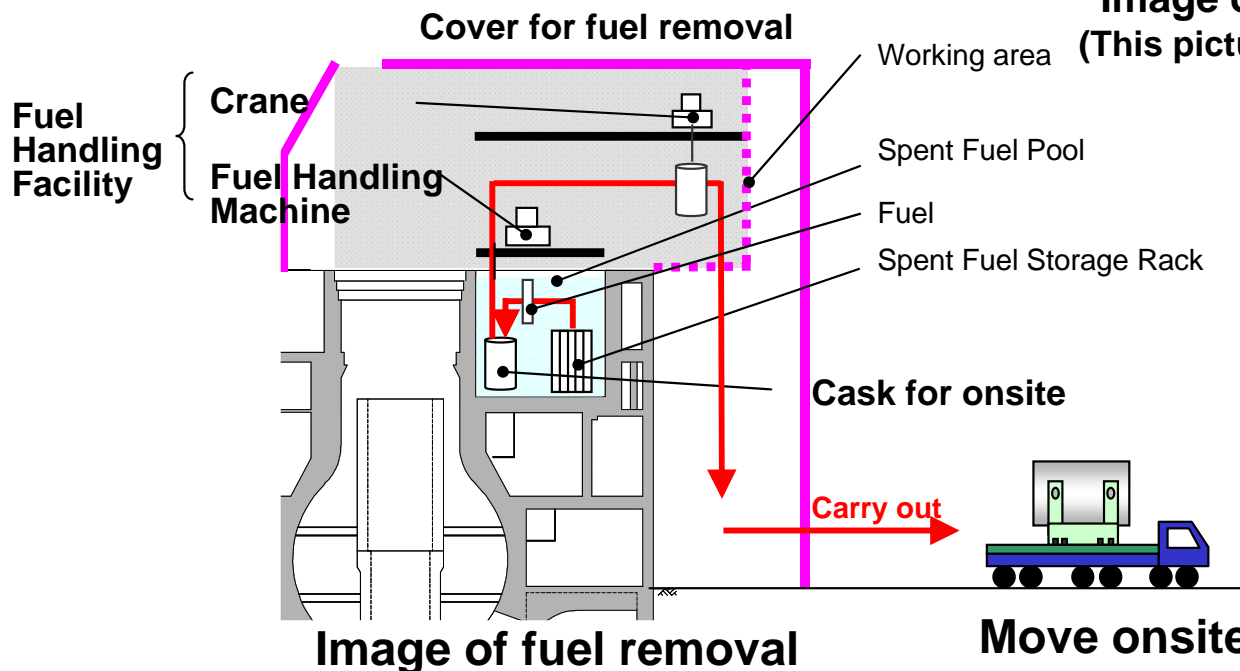
Image of the cover for fuel removal in Unit 4
(This picture shows only a image of the general plan.)

Plan to remove spent fuels in Unit 4

- The cover for fuel removal already installed in order to improve work environment and to prevent radioactive materials from scattering and releasing during the work.
- Start of fuel removal at Unit 4 is planned at Nov. 2013.

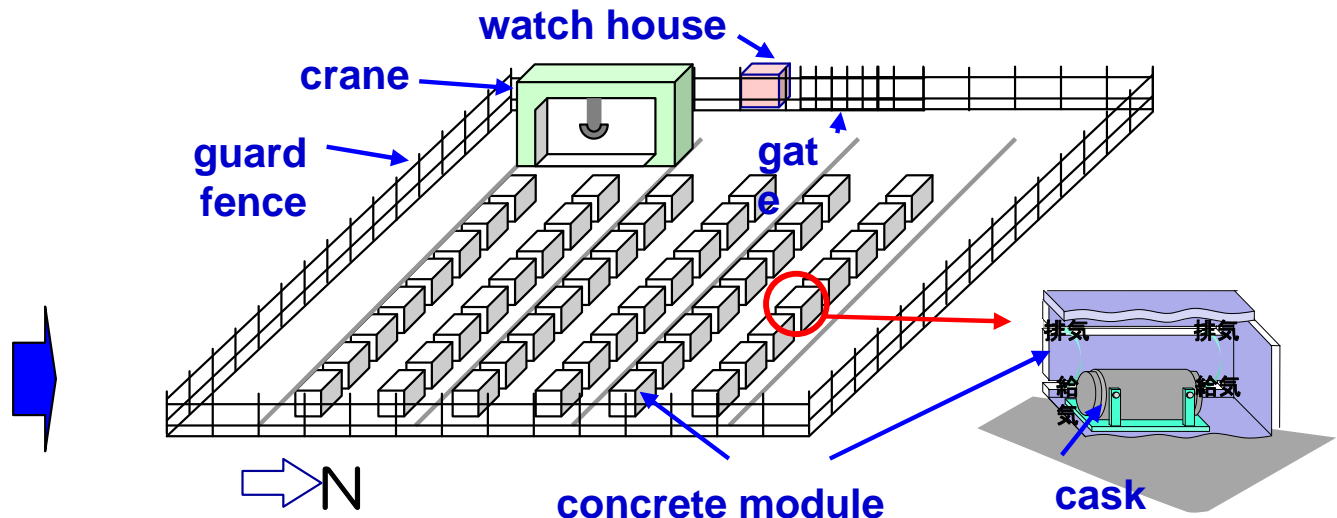
- Ensure an area to receive and store the fuel removed from the spent fuel pools
- The spent fuel currently stored in the common pool will be stored in dry casks and move out of the common pool, and temporary stored.

① Fuels in the spent fuel pools are transferred to the common pool by shipping cask

② Fuels in the common pool will be stored in casks and move to Temporary cask custody area.

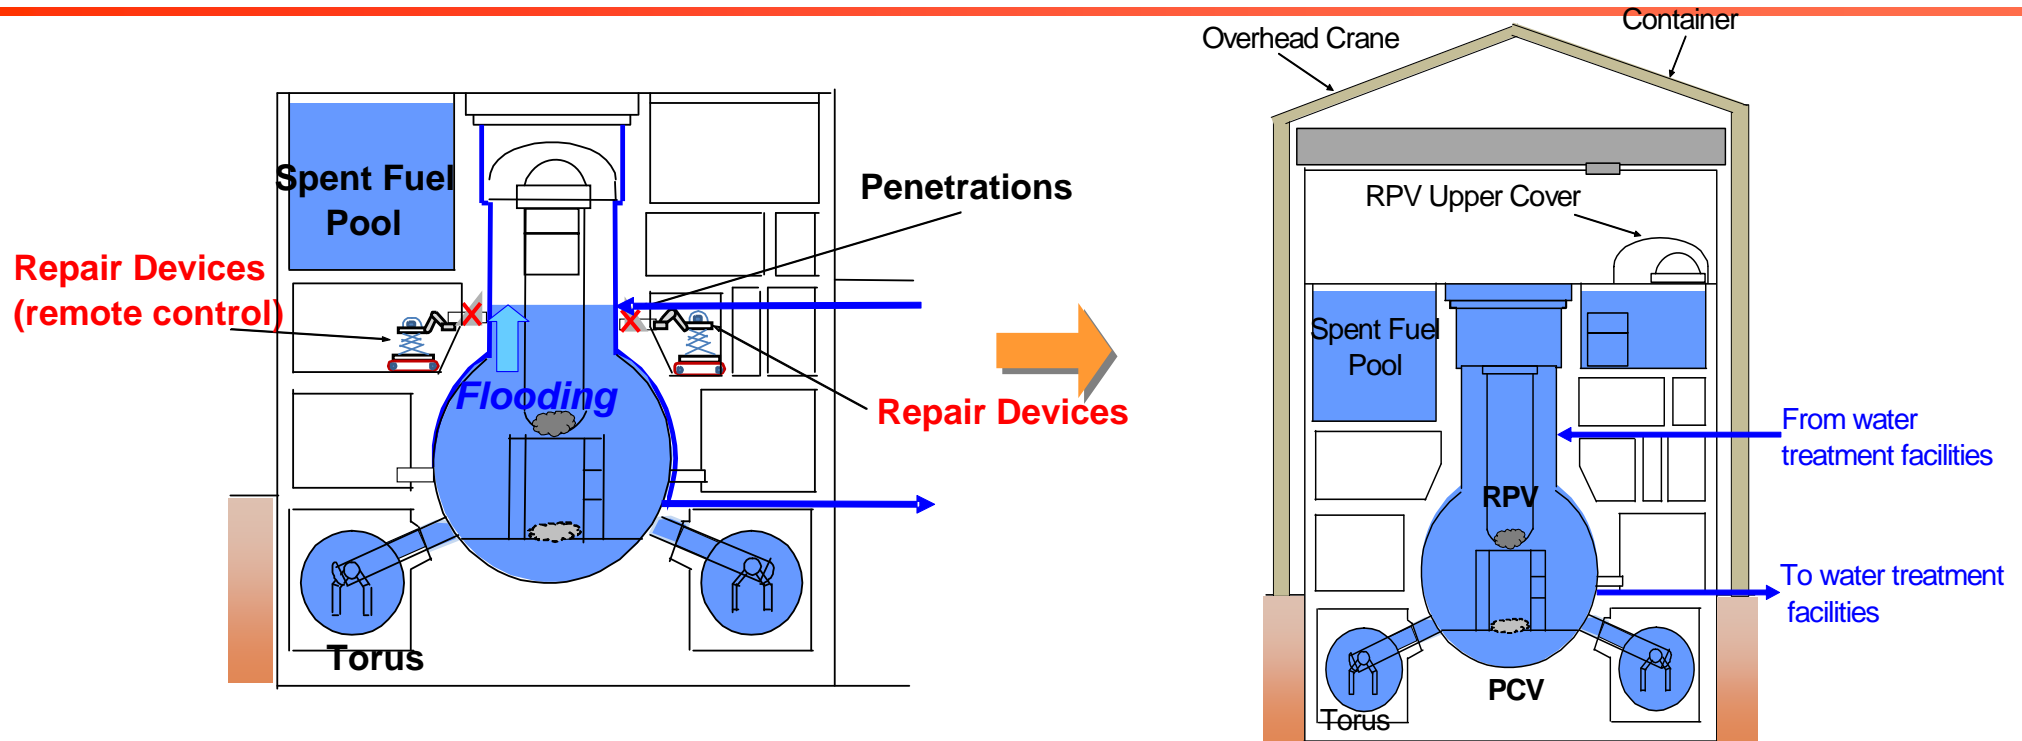
Steps 6,7: Upper PCV repair, Flooding of Entire Reactor Well

- (1) Filling entire PCV/RPV with water after repairing upper PCV
- (2) R/B container and overhead crane will be installed for defueling.
- (3) RPV/PCV top heads will be removed after sufficient water is attained

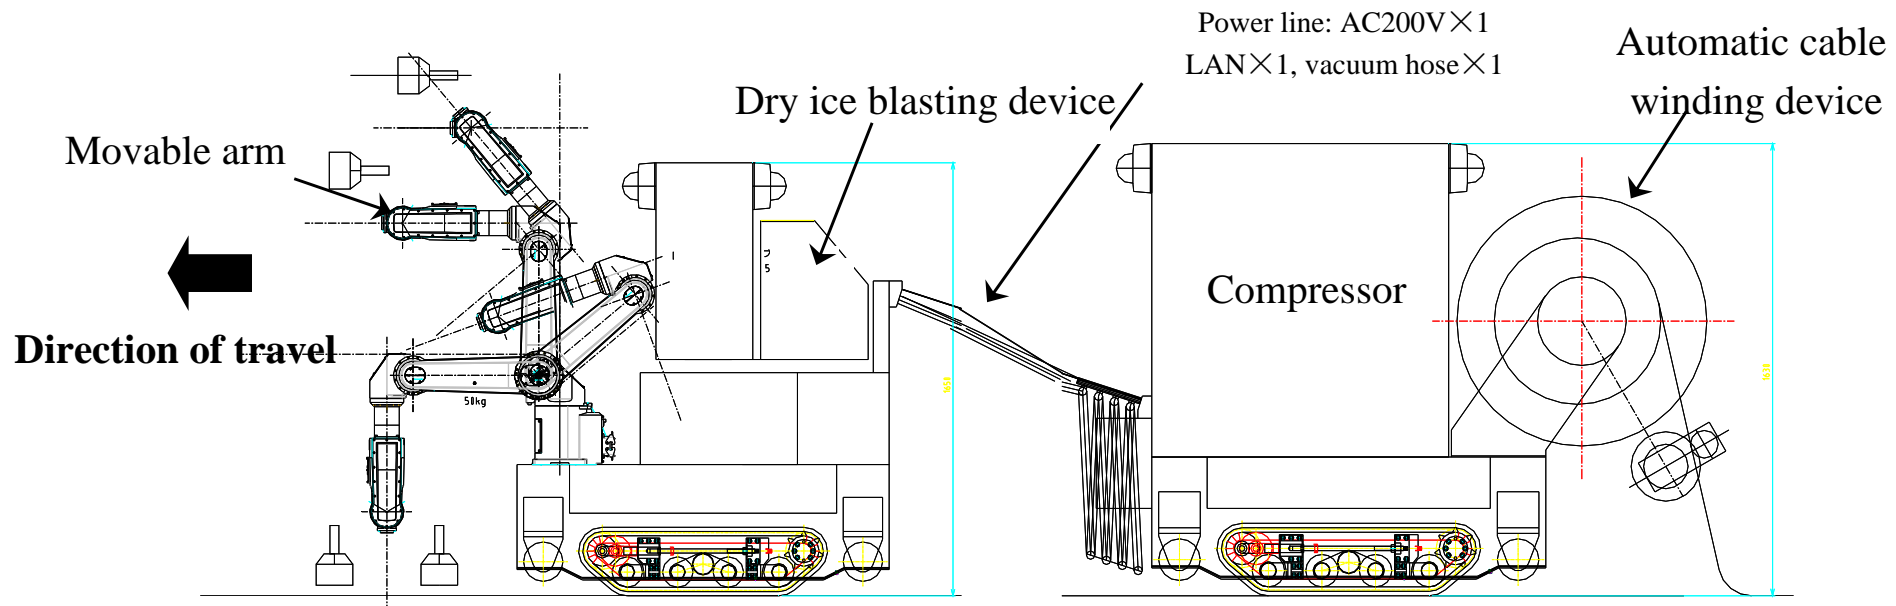
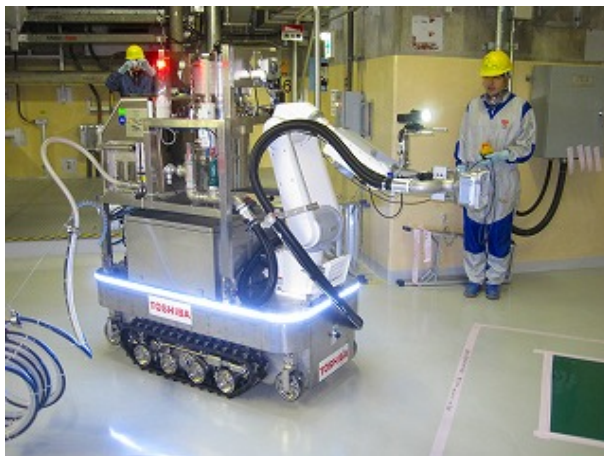
Mechanical decontamination of surfaces by spraying dry ice powder.
It leaves little secondary waste because dry ice sublimates.
It doesn't damage decontaminated surface.

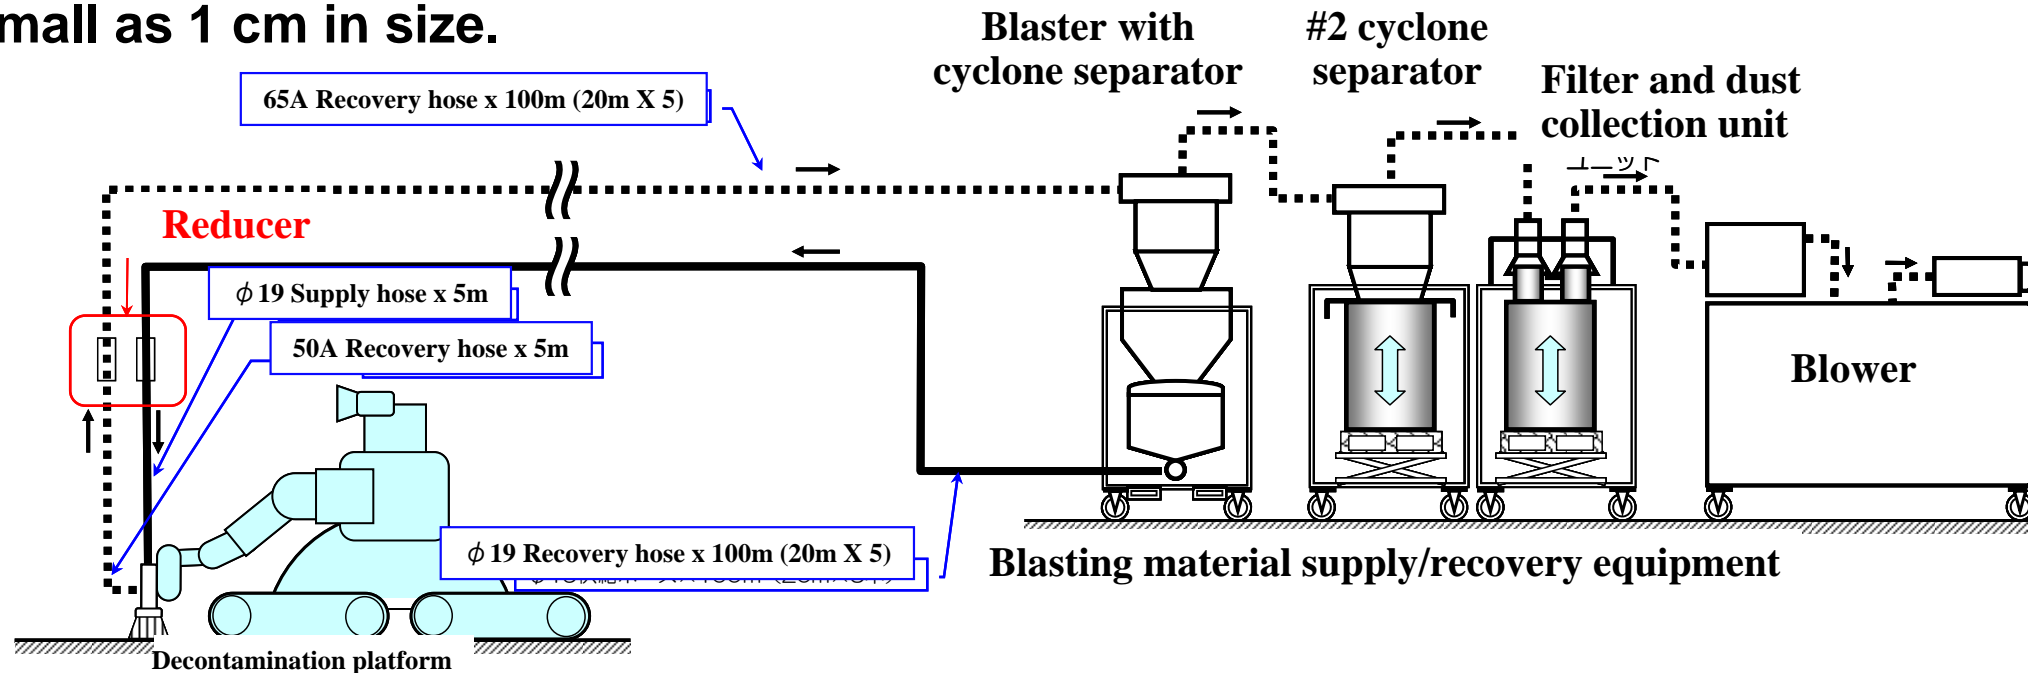
It can be running in suction only mode and is capable of recovering debris as small as 1 cm in size.

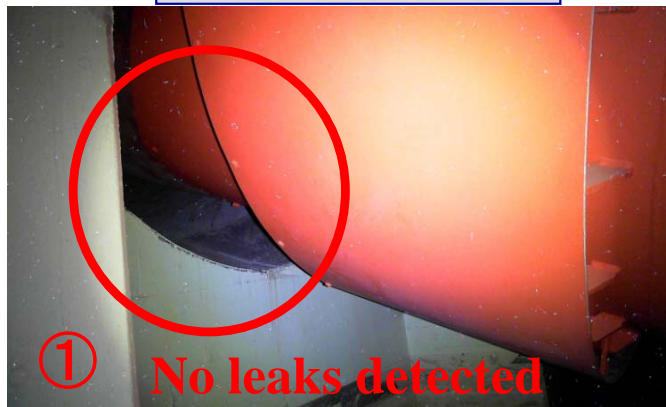
Enlarged view of area beneath pipes

① No leaks detected

Vent pipe sleeve end

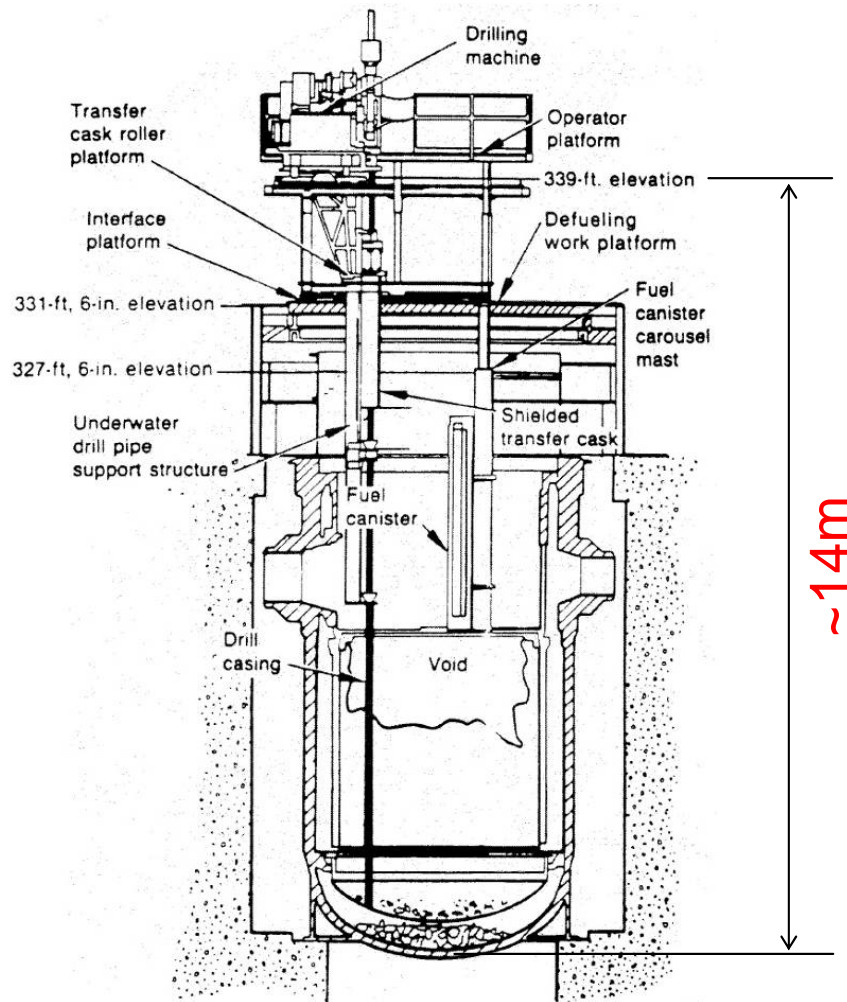
Core Boring Machine for TMI-2

The Cleanup of Three Mile Island Unit 2,
Project 2558-8 Final Report, EPRI NP-6931 (1990)
